Atlantic Station Report

Atlantic Station: Bridging Barriers

Atlantic Station & Four Surrounding Blocks

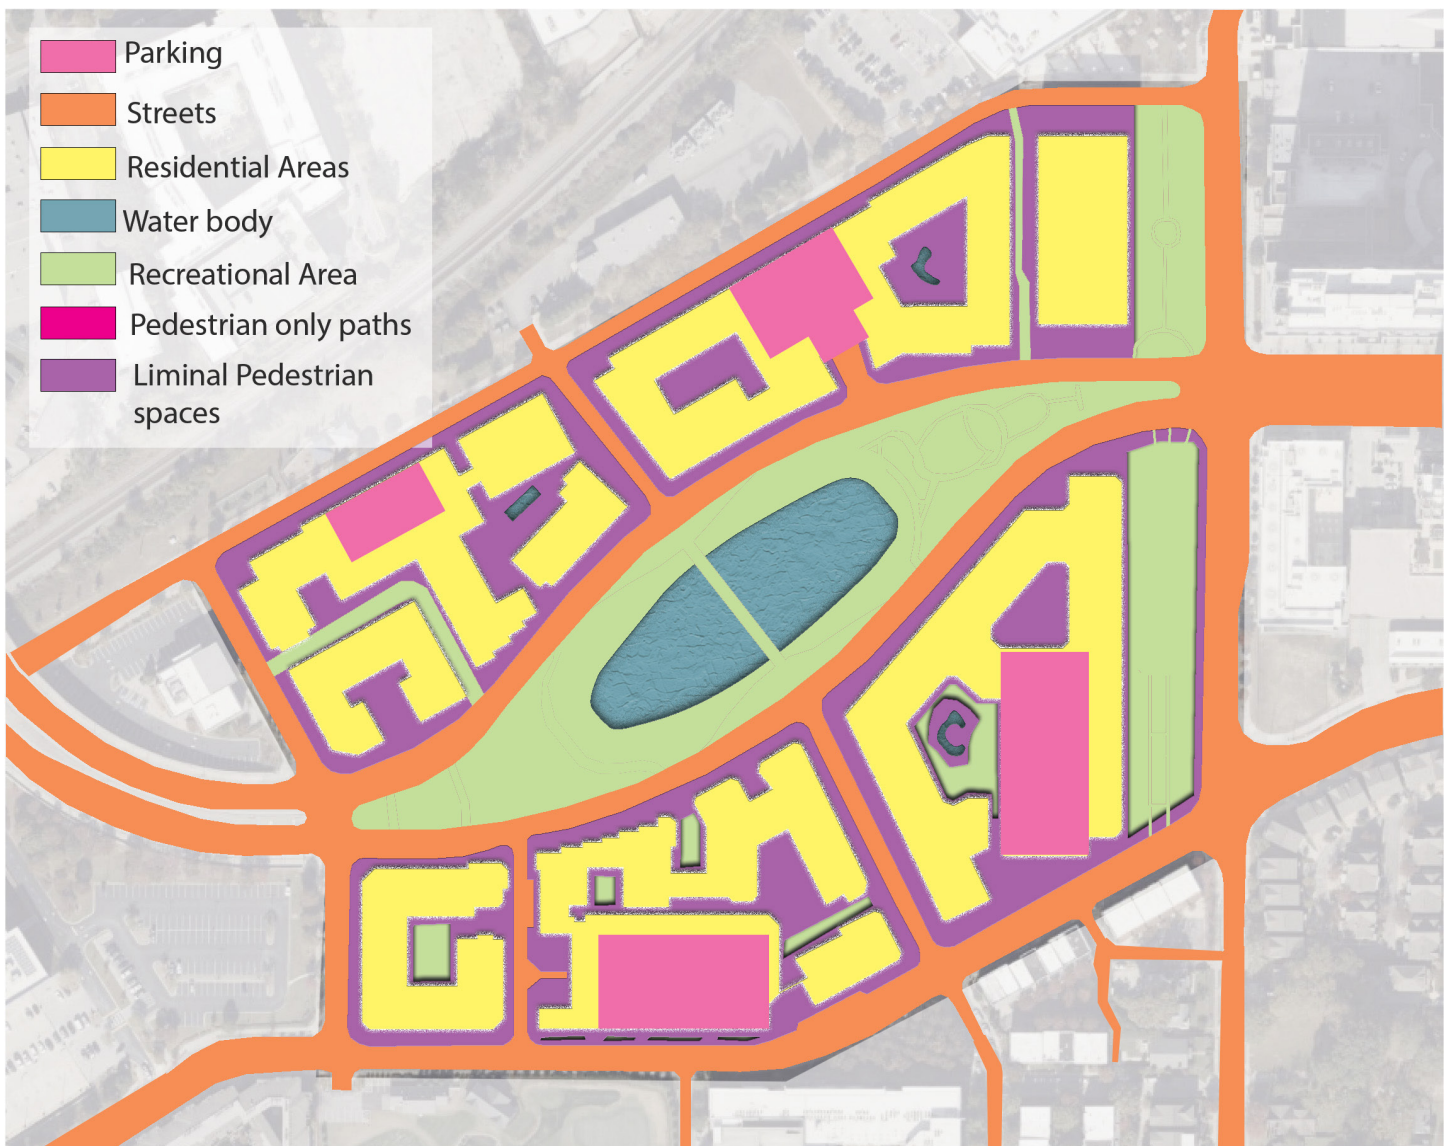
b) Spaces and Zoning

Analysis of spatial zones illustrates:

1. Heavy street encirclement limiting pedestrian permeability.
2. Pedestrian paths existing only in fragmented pockets.
3. Dominance of liminal pedestrian spaces (spaces without clear function or safe design).

Recreational areas being largely insular rather than connected to wider pedestrian networks.

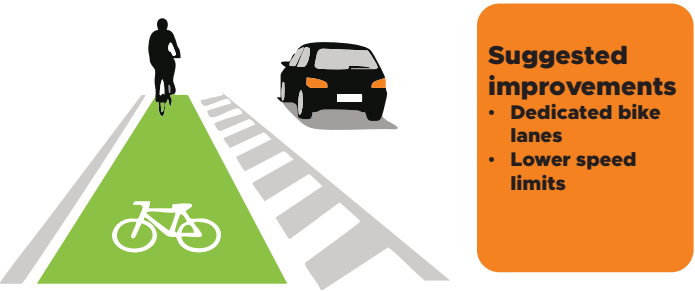
d) Suggested Improvements

Frequently suggested improvements to include enhanced pedestrian crossings, dedicated and clearly marked bike lanes, reduced vehicular speeds, and better wayfinding.

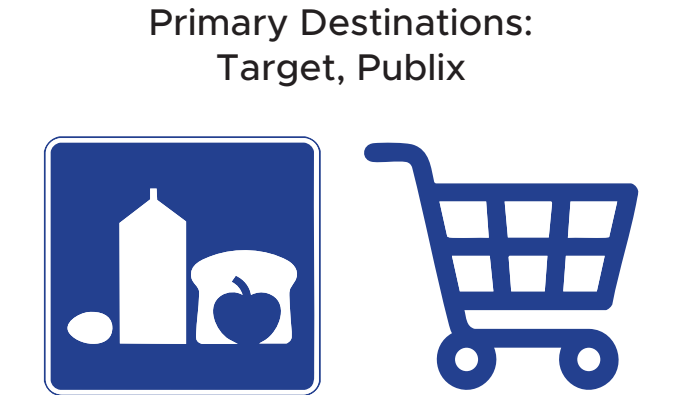
e) Primary Destinations

Popular destinations included the central green space, commercial establishments off the site, and recreational amenities, reinforcing the necessity of improving pedestrian and cyclist connectivity. However respondents mostly cited superstores as destinations, making it seem that another consideration is distance and ease of carrying items.

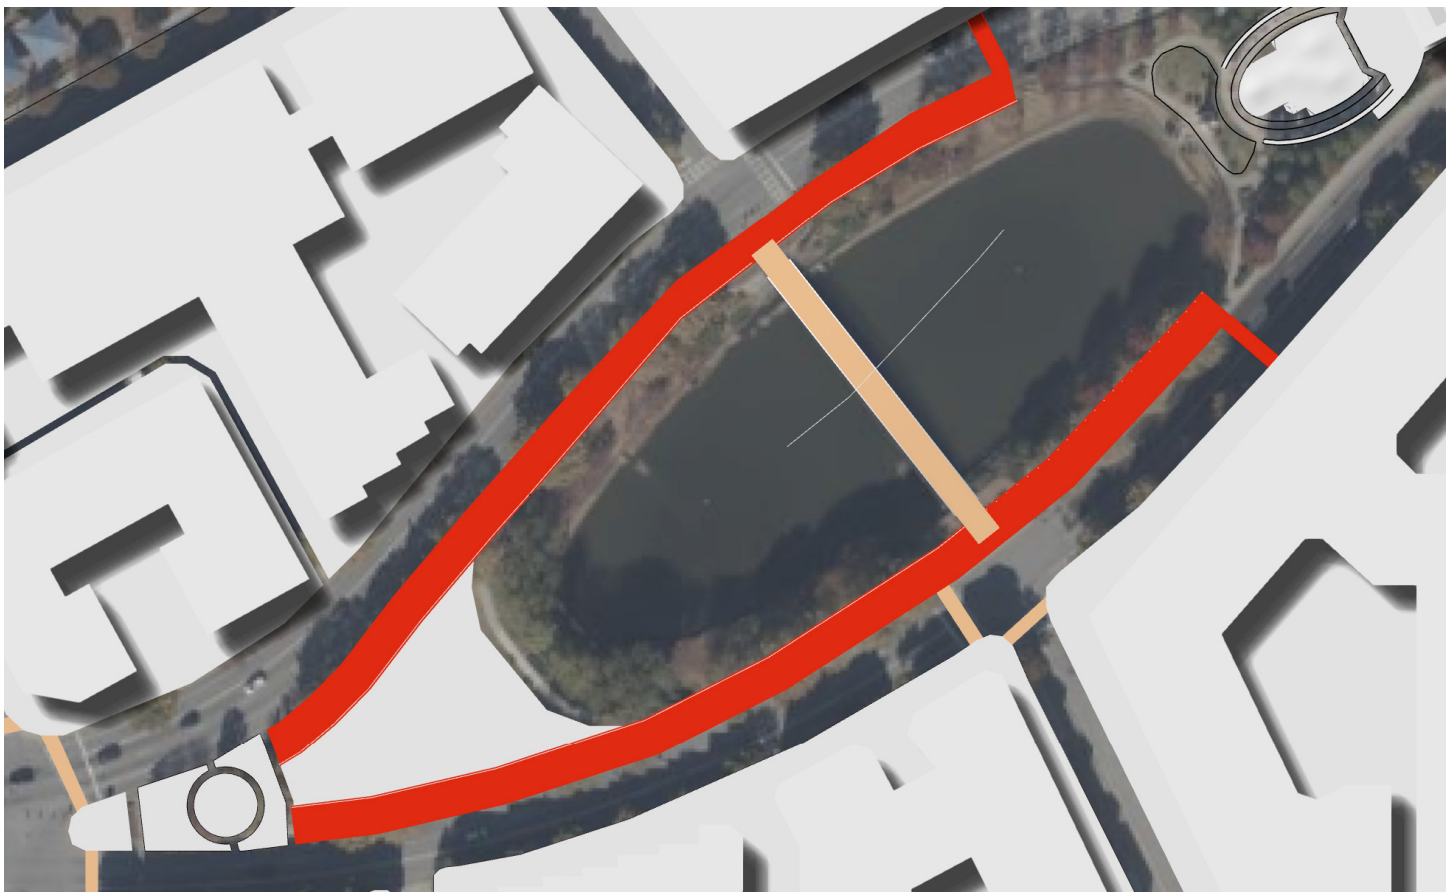
b) Dedicated Bicycle Path

A continuous bikeway is proposed to loop around the central green space, providing cyclists with a dedicated lane that minimizes conflicts with pedestrians. This intervention is envisioned as a painted or segregated lane within the internal pedestrian realm.
